Manhole Inspection Summary

Manhole # S23II_058MH

Insp Date: **10/9/07 8:42 AM**

Location Address: **1654 GILMOR ST**

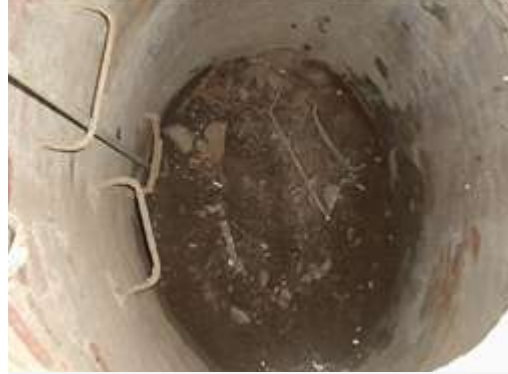
Top View

Corroded steps. Channel debris.

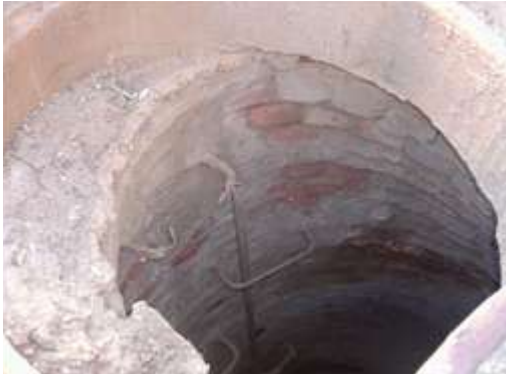
Defect

Frame leaks. Frame offset. Adjustment deterioration and infiltration. Barrel infiltration.

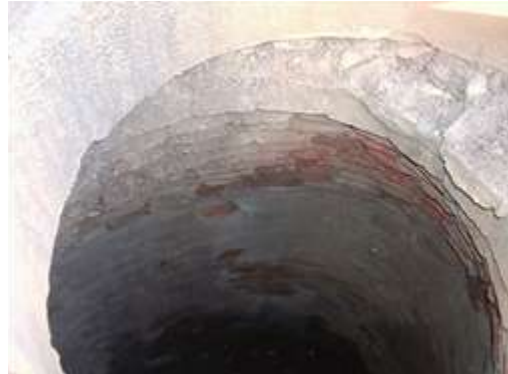
Defect

Frame leaks. Frame offset. Adjustment deterioration and infiltration. Corbel and Barrel infiltration - other side.

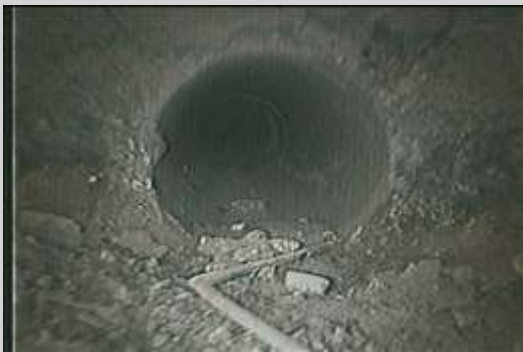
8 in. Circular Gravity Sewer
Pipe Out @ 12 O'Clock

Rod and Bar (Angled)
